POTENTIAL USE OF GROUND PENETRATING RADAR IN HIGHWAY ROCK CUT STABILITY

Norbert H. Maerz* and Wooyoung Kim^

*Rock Mechanics and Explosives Research Center, University of Missouri-Rolla,
Rolla, MO, 65409-0660, USA, norbert@umr.edu

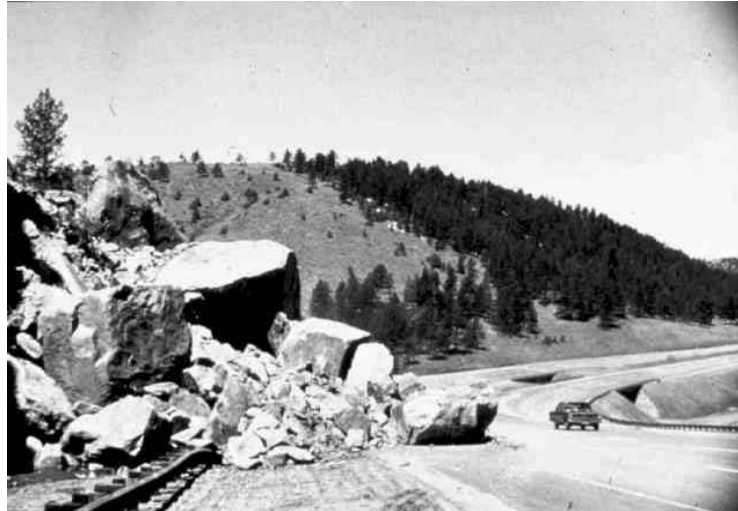
Figure 1. Example of a rock failures causing obstruction of a roadway.

Ensuring the stability of highway rock cuts, whether new or old requires an evaluation of the structure of the rock. Failure results in blocked roads, property damage, injury, and loss of life (Figure 1). Failures usually initiate and follow pre-existing discontinuities rather than break through intact rock (Figure 2). Failures are typically triggered either by seismic activity, high groundwater pressures, ice wedging, or progressive deterioration of the intact rock because of weathering.

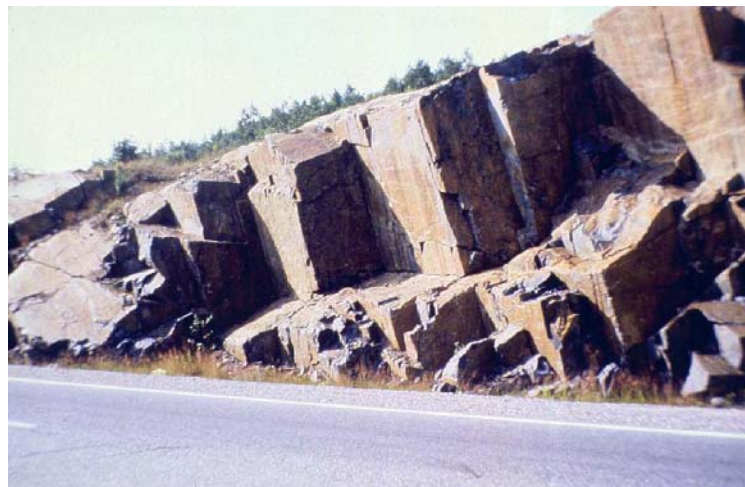
Figure 2. The discontinuous nature of rock masses (Highway cut in Nova Scotia, Canada)

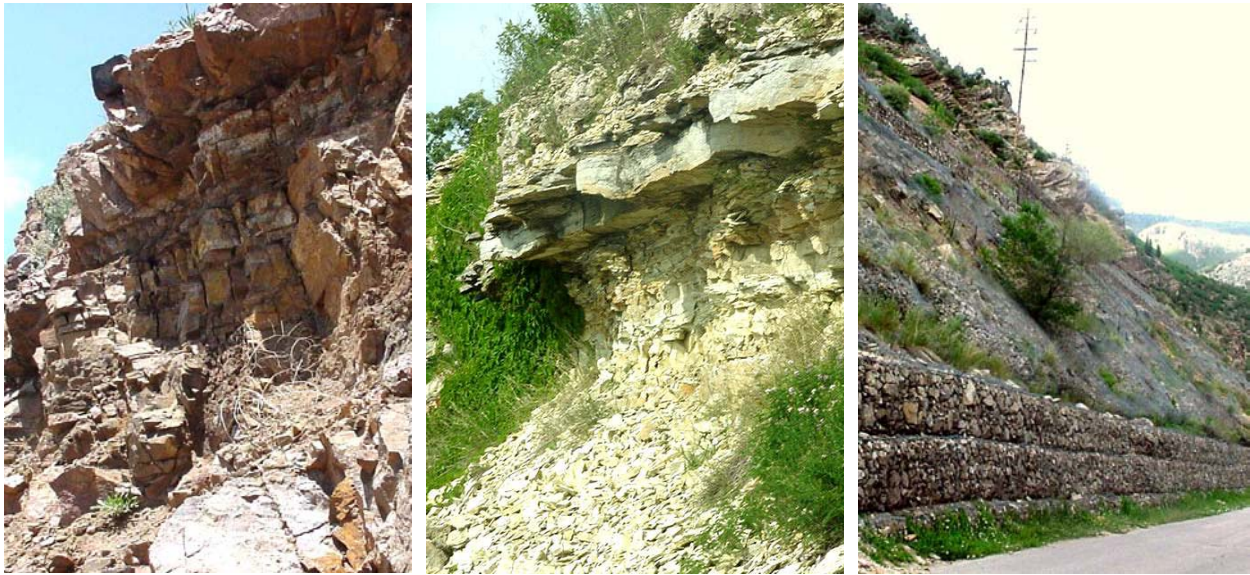
Figure 3. Raveling, undercutting, and rolling failures along road cuts, respectively, Colorado, Highway 70.

Failures in rock cuts occur as a result of several mechanisms. Figure 3 shows raveling, undercutting, and rolling failures. These types of mechanisms are in general not conducive to predictive calculations or modeling, but rather require engineering judgment to determine whether they are likely to fail or to remain stable. Methods for analysis are described in Franklin and Maerz (1996).

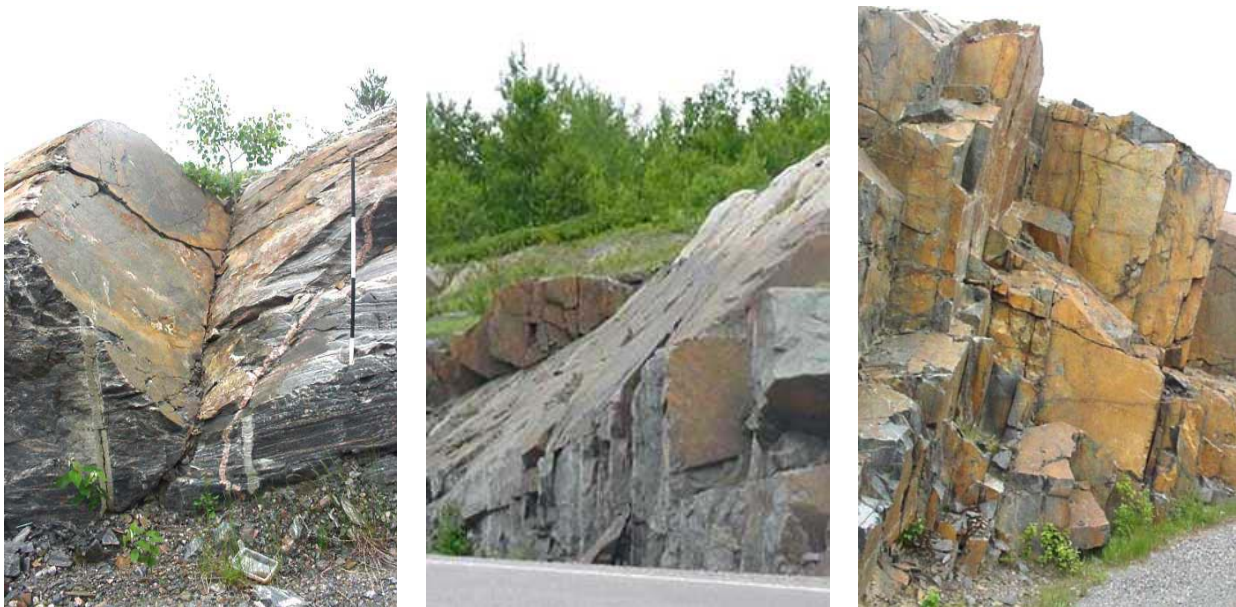
Figure 4. Example of wedge, planar, and toppling failures along road cuts, respectively, Sudbury, Canada.

Figure 4 shows examples of wedge, planar, and toppling failures. What these mechanisms have in common is that they are all conducive to predictive calculations or numerical modeling, ranging from simple limiting equilibrium analysis to sophisticated numerical modeling (Hoek and Bray, 1981; Piteau, 1979c; Piteau, 1979d; Piteau, 1979e), and a determination of their stability can be made on the basis of these algorithms.

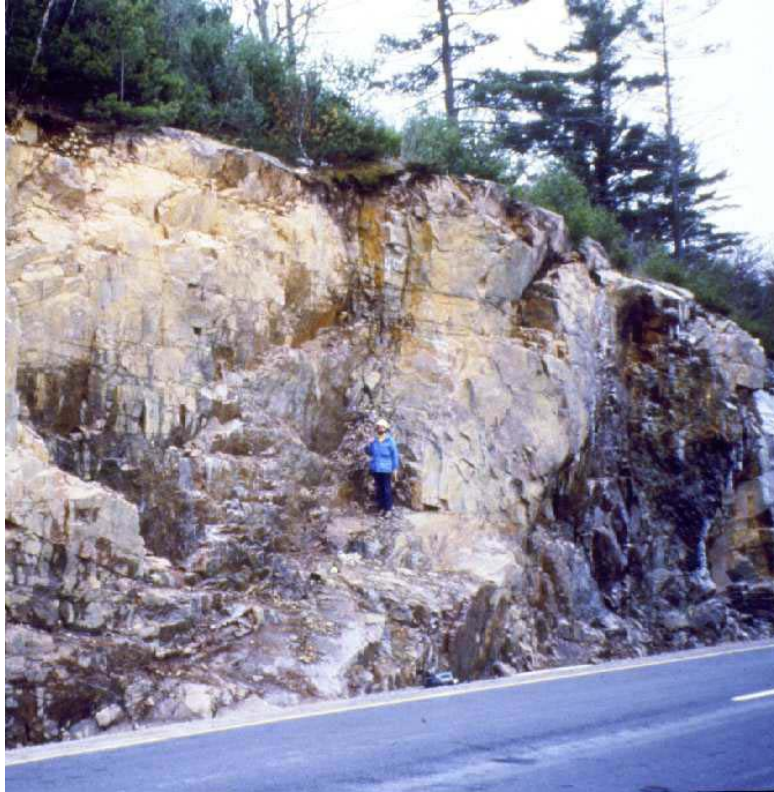
Figure 5. Failed rock cut, Hwy 401, Brockville, Ontario, Canada, after removal of rubble. The failed material released along a sub-vertical joint, exceeded the capacity of the ditch, spilled out onto the left lane to a depth of one meter, resulting in the death of a truck driver.

Vertical discontinuities contribute to a significant proportion of rock cut failures precisely because they are so difficult to detect. Figure 5 shows a cut where failure along one such discontinuity, in this case sub-parallel to the road cut, caused the death of a truck driver.

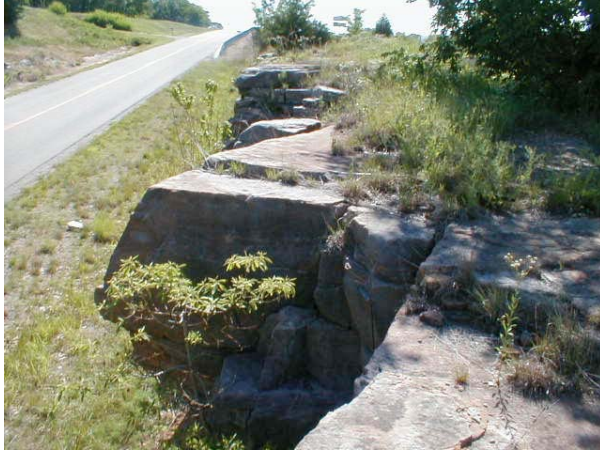
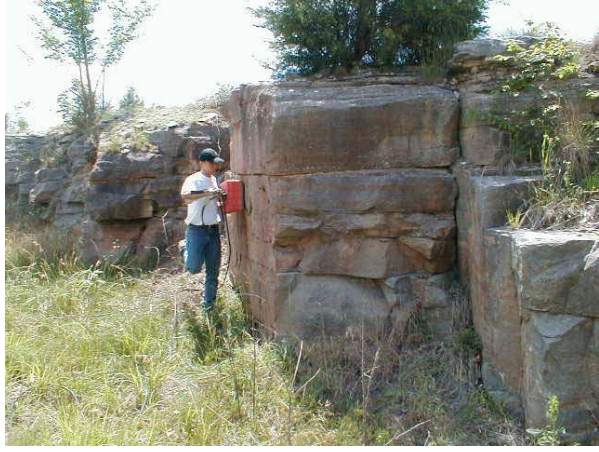
Figure 6. Obliquely striking vertical joints in sandstone of the Roubidoux Formation.

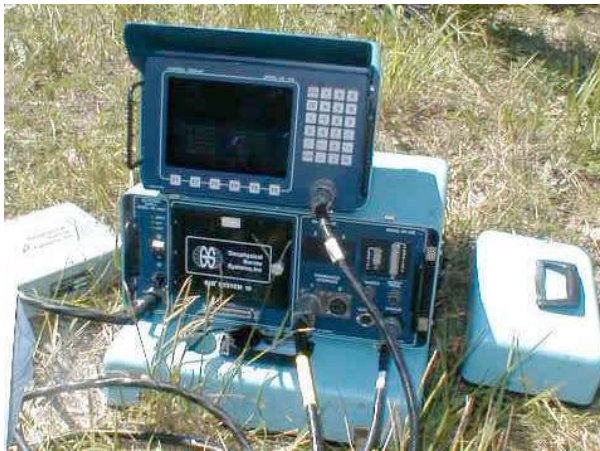
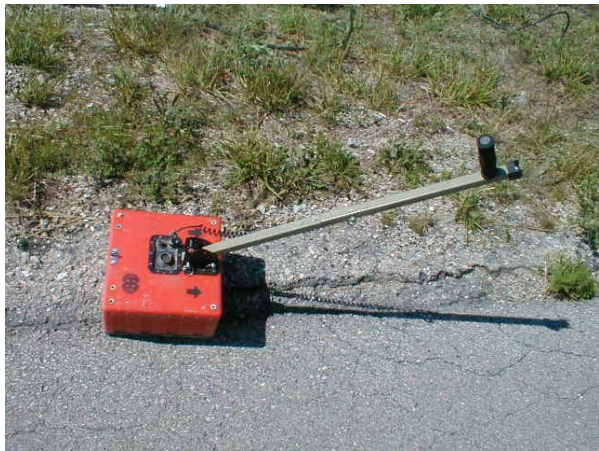
Figure 7. SIR10B ground penetrating radar system, showing a 400 MHz. antenna.

A Geophysical Survey Systems Inc. SIR10B ground penetrating radar unit was used to make the measurements (Figure 7). Three antennas were employed. 400 MHz, 900 MHz, and 1500 MHz (The higher the frequency the greater the resolution, the lower the frequency, the greater the depth of penetration).

In this study, preliminary results showed that only the 400 MHz antenna penetrated deeply enough into the rock to clearly identify the fractures. Consequently only the 400 MHz antenna data was recorded and analyzed.

Survey lines were run multiple times horizontally across the rock cut for distances between 6 and 12 feet. The data sampling rate was set at 50 scans per second, using an 800 MHz low pass filter and a 100 MHz high pass filter.

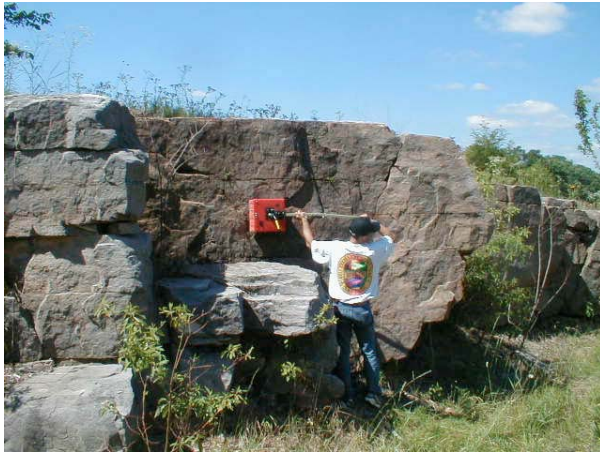
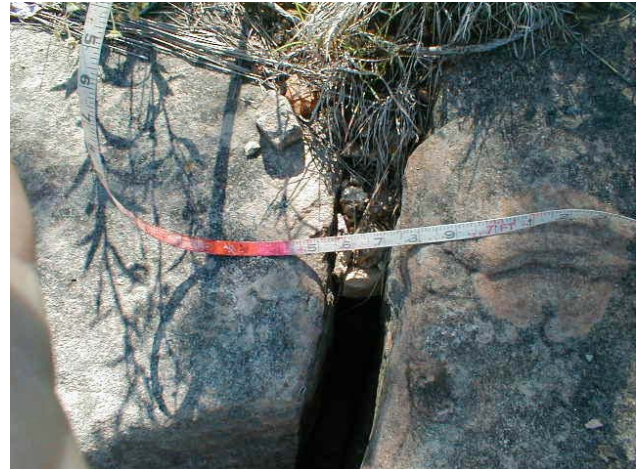
Figure 8. Site 1 with a 2" soil filled vertical joint, 7' deep into the rock.

Figures 8 and 9 show that GPR is able to find the open structure at a depth of about 7'. The two or three weaker reflections at shallower depth may be joints that are fully closed or blast induced fractures. Figures 10 and 11 show a somewhat weaker signature from joints that appear to be closed, or have a very small aperture.

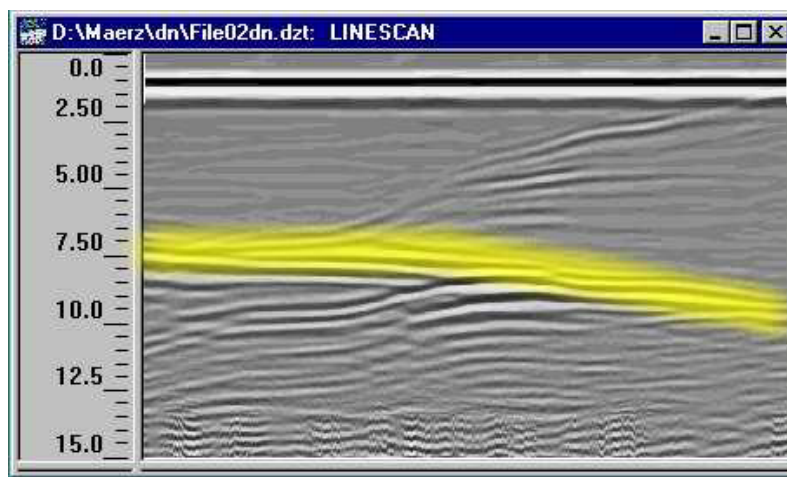
Figure 9. Site 1 survey results for 2" aperture on a vertical joint, at a depth of 7', measured by tape measure at the center of the profile (signature highlighted, scale of profile is in feet).

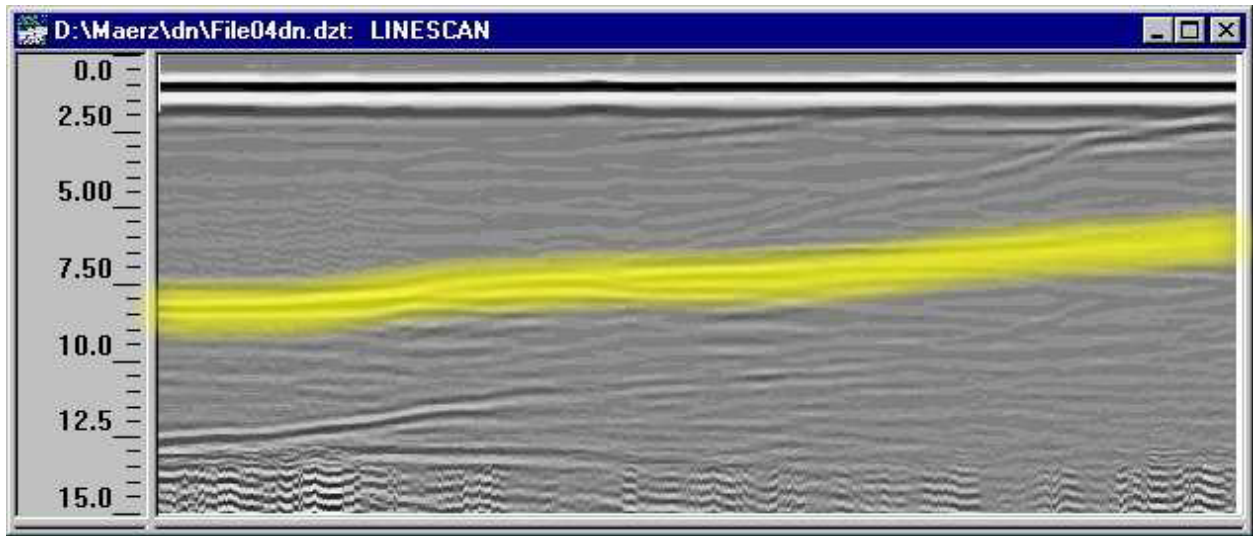
Figure 10. Site 2 survey results for <1" aperture on a vertical joint, at a depth of 7', measured by a tape measure at the center of the profile (signature highlighted, scale of profile is in feet).

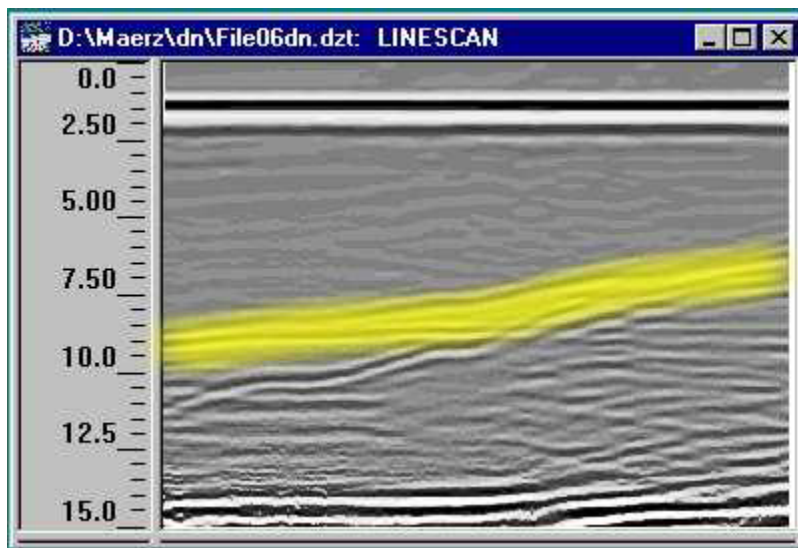
Figure 11. Site 3 survey results for <1" aperture on a vertical joint, at a depth of 5', measured by a tape measure at the right end of the profile (signature highlighted, scale of profile is in feet).

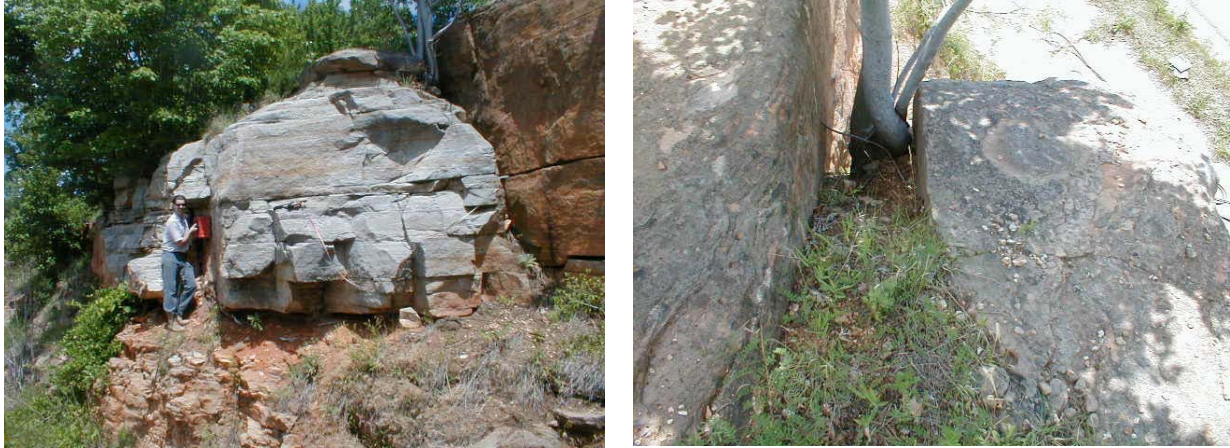
Figure 12. Site 4 with a 12" soil filled vertical joint, 10' deep into the rock'.

Figure 13 reveals a stronger signature for a joint with a much larger aperture. The two or three weaker reflections at shallower depth are indicative of the smaller shallower joints seen in Figure 12.

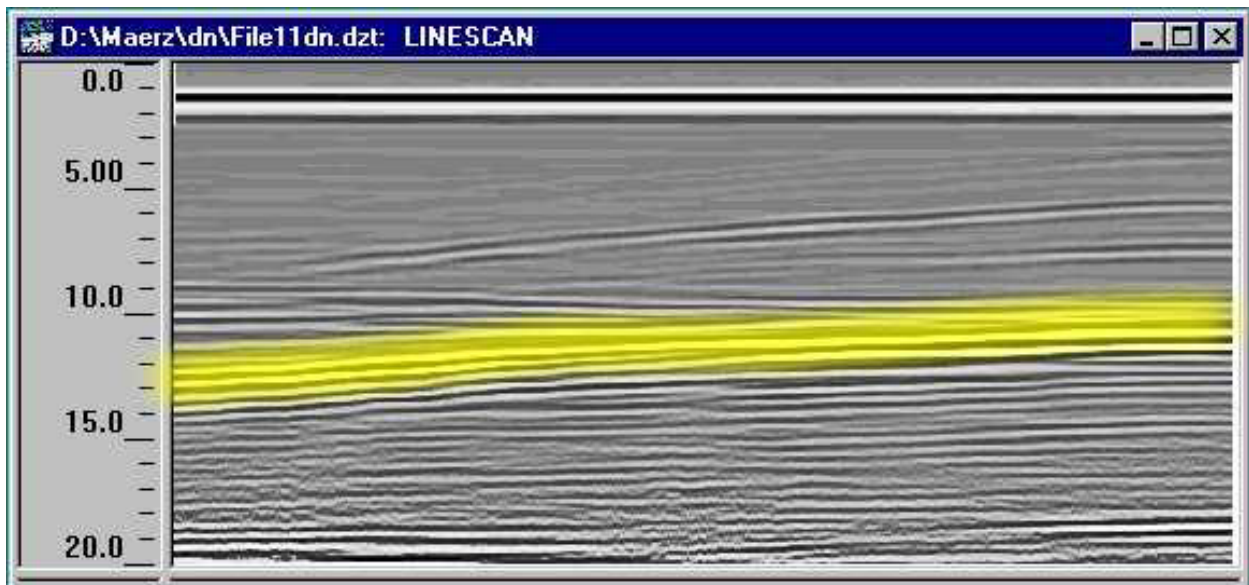
Figure 13. Site 4 survey results for 12" aperture on a vertical joint, at a depth of 10', measured by a tape measure at the right end of profile (signature highlighted, scale of profile is in feet).
