Maerz, N. H., Youssef, A., and Lauer, R., 2004. MORFH RS: A rockcut rating system for Missouri highways. 55th Highway Geology Symposium, Kansas City, Missouri, Sep. 7-10, 2004, pp 406-424.

MORFH RS: A ROCKCUT RATING SYSTEM FOR MISSOURI HIGHWAYS

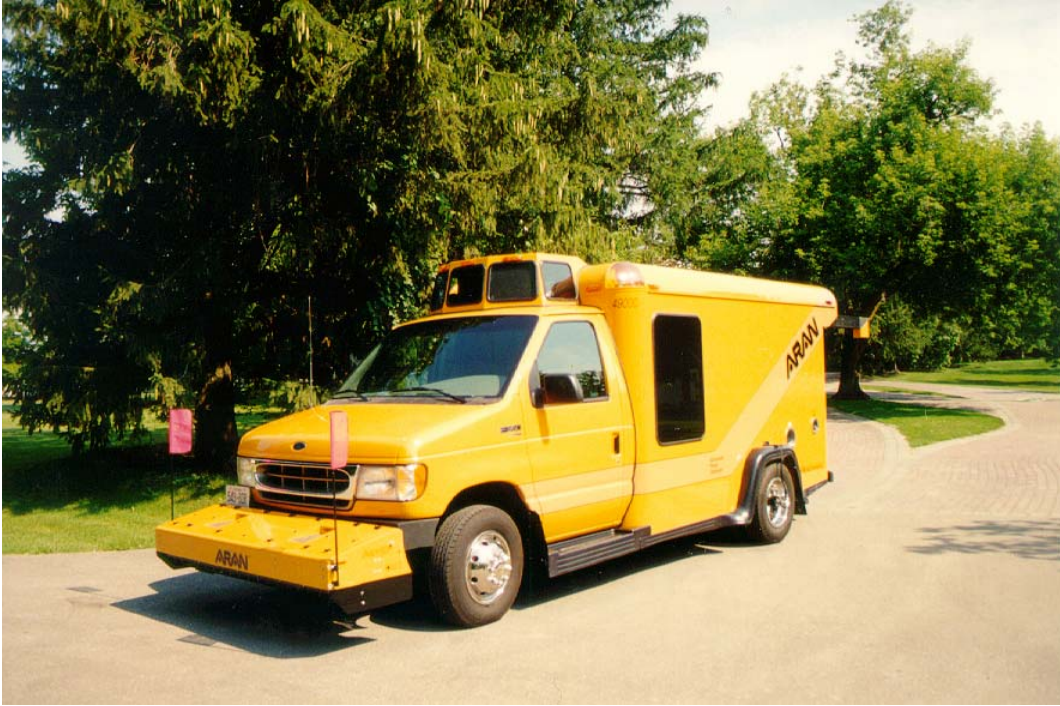
Figure 1. An example of an Automatic Road Analyzer (ARAN) made by RoadWare Corporation.

MORFH RS is based on mobile highway video technology, which means that highway rock cuts can be routinely imaged (video logged) at highway speeds by technicians, and the video can be replayed at the office where engineers or geologists can rapidly screen the cuts and determine which need more detailed assessment. Video screening can be done using a sophisticated fully instrumented vehicle such as RoadWare's ARAN (Figure 1) (Maerz and McKenna, 1999) or as simple as a video camera mounted in a car or truck (Figure 2) (Maerz et al., 2003).

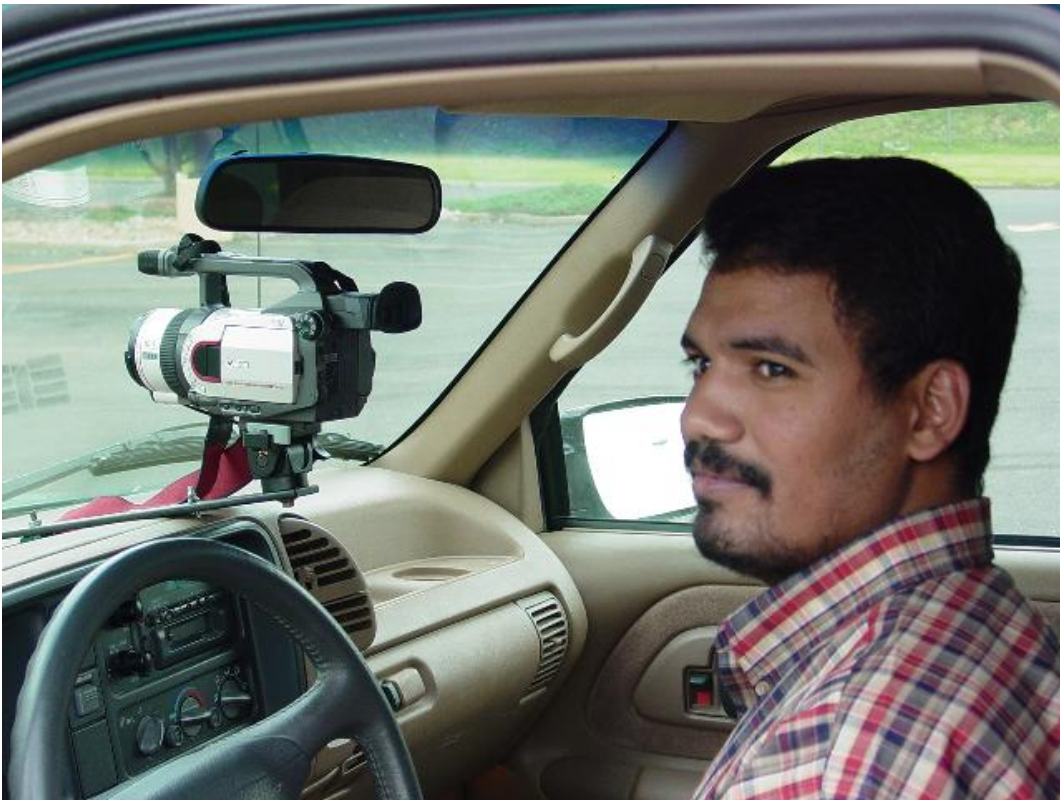
Figure 2. Simple video setup.

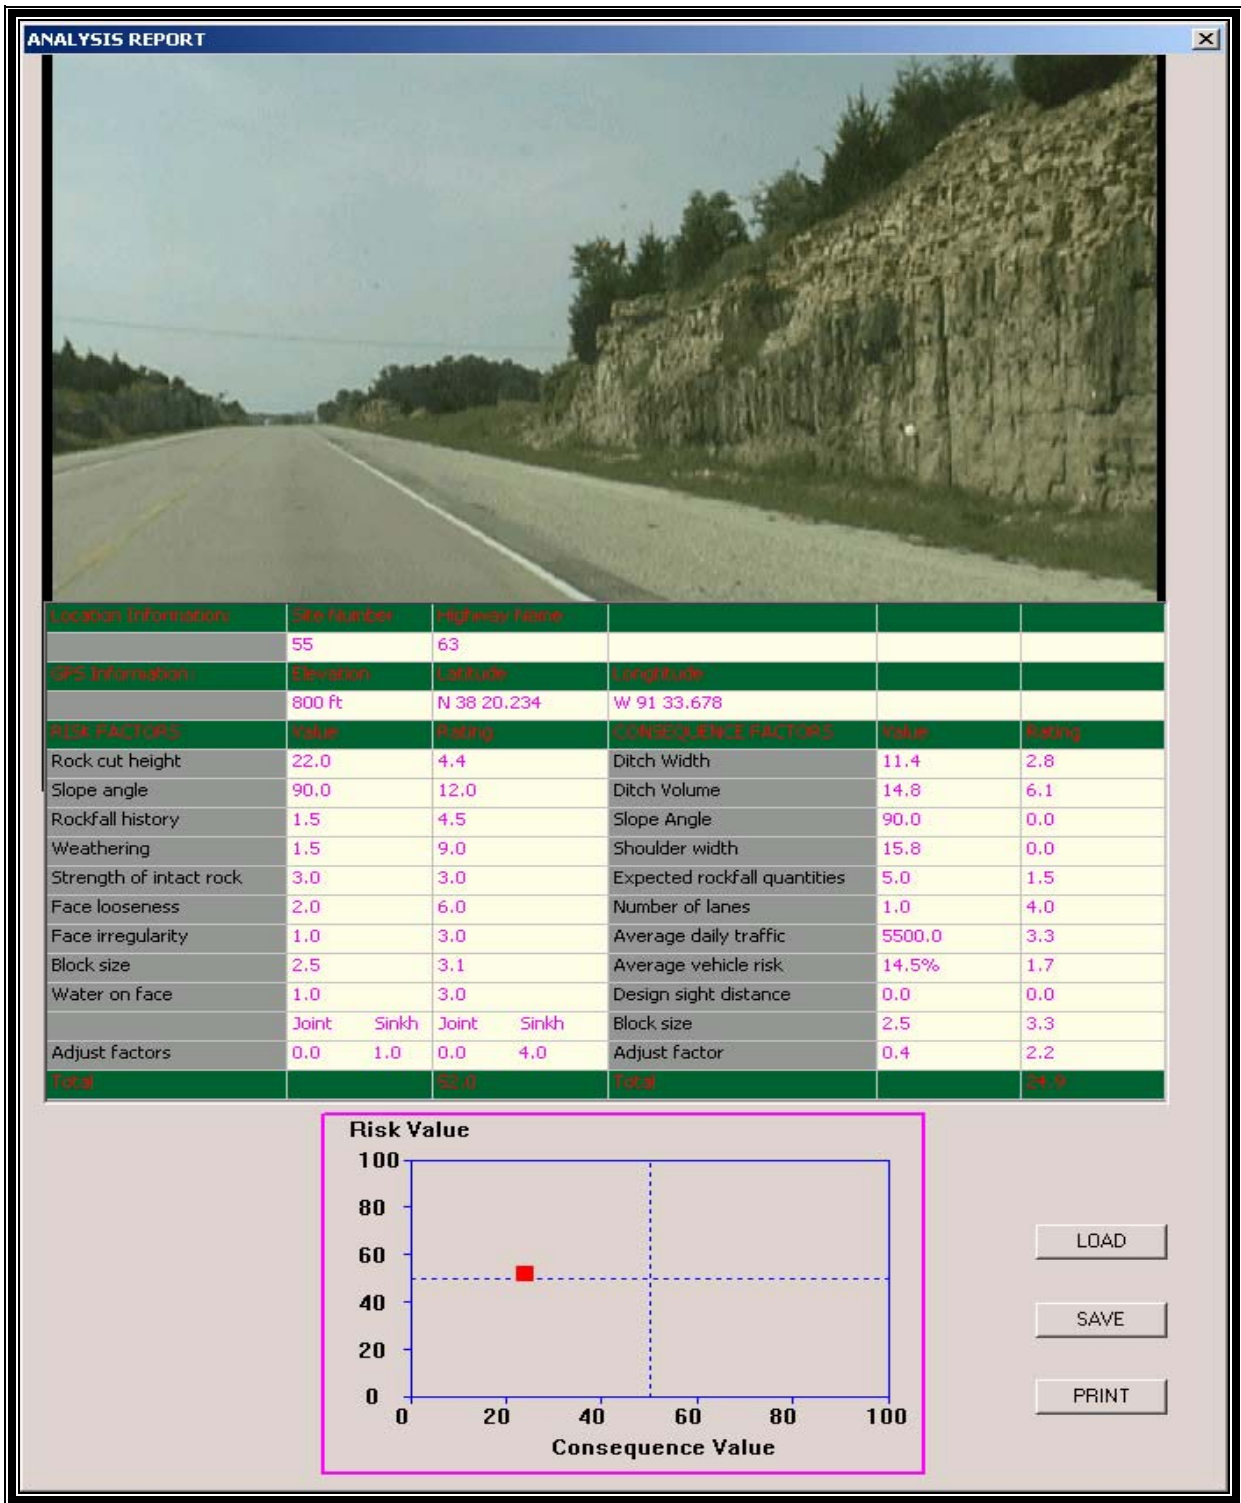
Figure 3: Single page report shows the results of evaluation.

The new Missouri rating system is predicated on separating risk (of failure) from consequence (of failure) (Figures 3, 4). While other rating systems may consider both risk of failure and consequence of failure factors, they tend to lump them together. This is incorrect, as some parameters affect risk and consequence in different ways. For instance, the larger the block size, the lower the risk of failure but the higher the consequence of failure. Or, a 90° slope would present the highest risk of failure, while perhaps a 30° slope would present the highest consequence for large rolling blocks and 85° from small bouncing blocks.

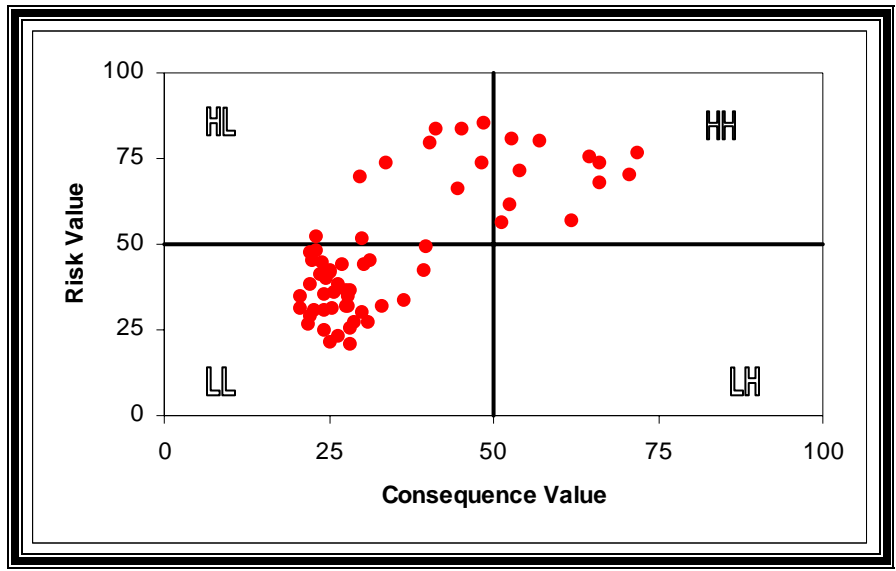
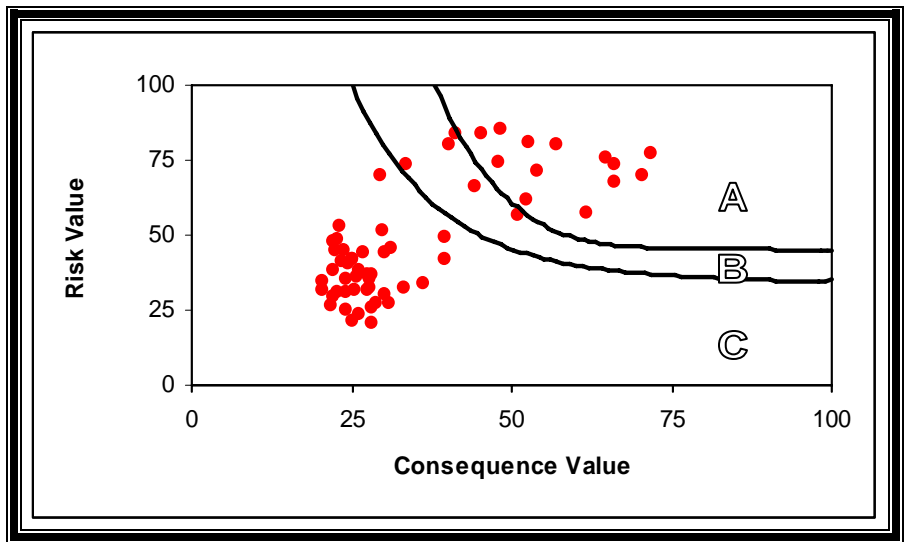
Figure 4. An example of a Risk – Consequence diagram for rock cuts from a section of highway 65 in Missouri. Top: diagram for the risk/quadrant data. LL = Low Risk Low Consequence, HL = High Risk Low Consequence, HH = High Risk, High Consequence, and LH = Low Risk High Consequence. Bottom: diagram for the zoned data. A= High Hazard Zone, B = Moderate Hazard Zone, and C = Low Hazard Zone.

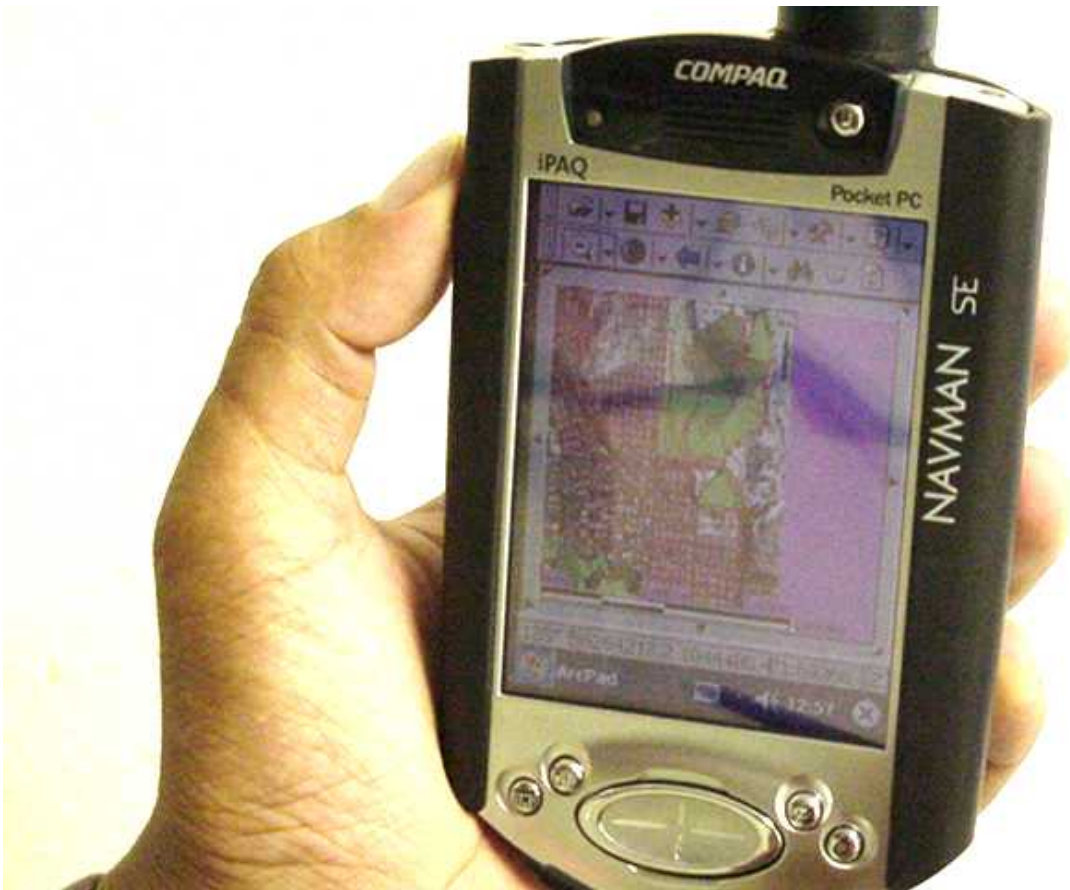
Figure 6. Compaq IPAQ PC with ArcPad software for field data collection.

As Missouri's roads are long and numerous the use of field data sheets became tedious. A digital data collection system for the field parameters was developed as well as a GIS database management system. For the sites that needed detailed rating, a Pocket PC (Compaq IPAQ with ArcPad[®]) (Figure 6) was used to edit the site locations, and add the field rated parameters. The IPAQ includes an optional Navman GPS receiver to automatically record the site locations.

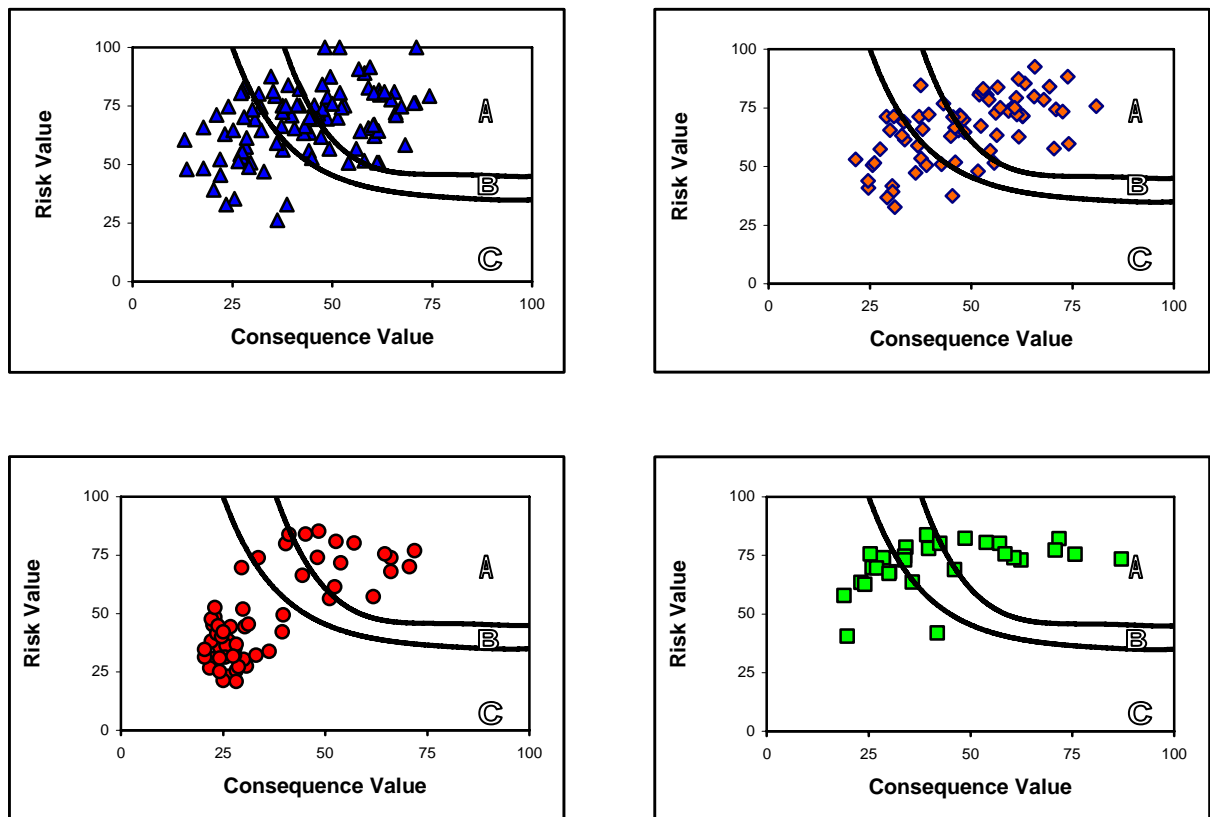
Figure 9. Results of analyses: Top left: Highway 63. Top right: Highway 44. Bottom left: Highway 65. Bottom right: Highway 54 (A= High Hazard Zone, B = Moderate Hazard Zone, and C = Low Hazard Zone).

During the development of the systems, over 500 rock cuts in Missouri were evaluated; over 300 were given detailed ratings. Figure 9 shows some typical analysis results for four Missouri highways. Typical Missouri highways contain older rock cuts in carbonate rock with some filled sinks and sandstone rock with large block sizes, highly weathered in some areas. The distribution of the data shows that the data fall in three zones: high risk-high consequence, high risk-low consequence, and low risk-low consequence. Significantly there are many in the high risk-high consequence section for all of the rock cuts. Notably for the highway 65 results, there are a substantial number of low risk-low consequence cuts. These are the new cuts that have been constructed in the last few years.
