Digital Imaging for Screening and Making Measurement of Features on Highway Rock Cuts

Highway rock cuts must be maintained for the safety of the motoring public. Since highways cover vast areas through differing geological terrains, it is not cost effective to remediate all rock cuts; remediation efforts have to be prioritized. Even doing traditional geological engineering evaluations on all the rock cuts is prohibitive.

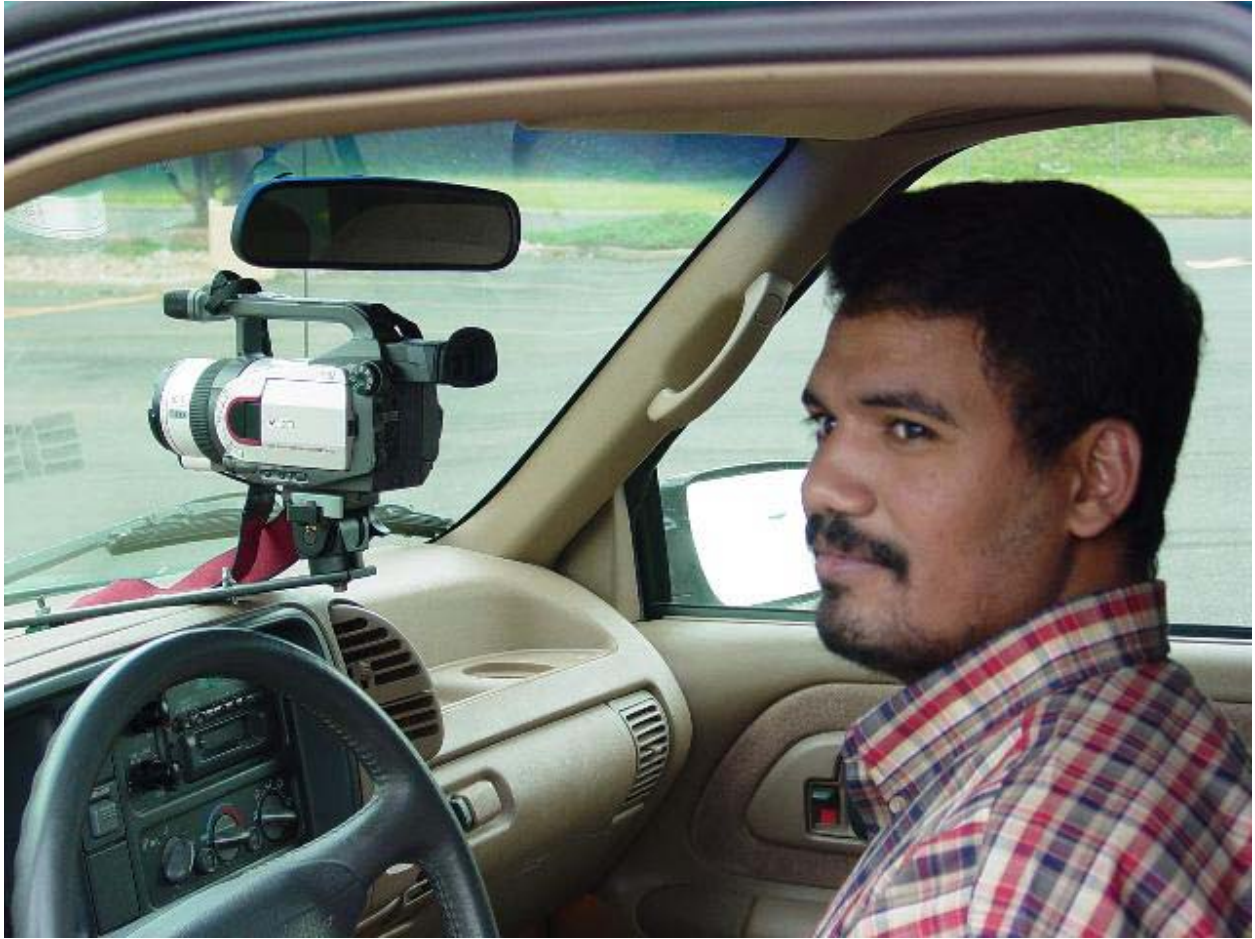
FIGURE 1 Digital camcorder mounted on vehicle dashboard.

FIGURE 1 Digital camcorder mounted on vehicle dashboard.

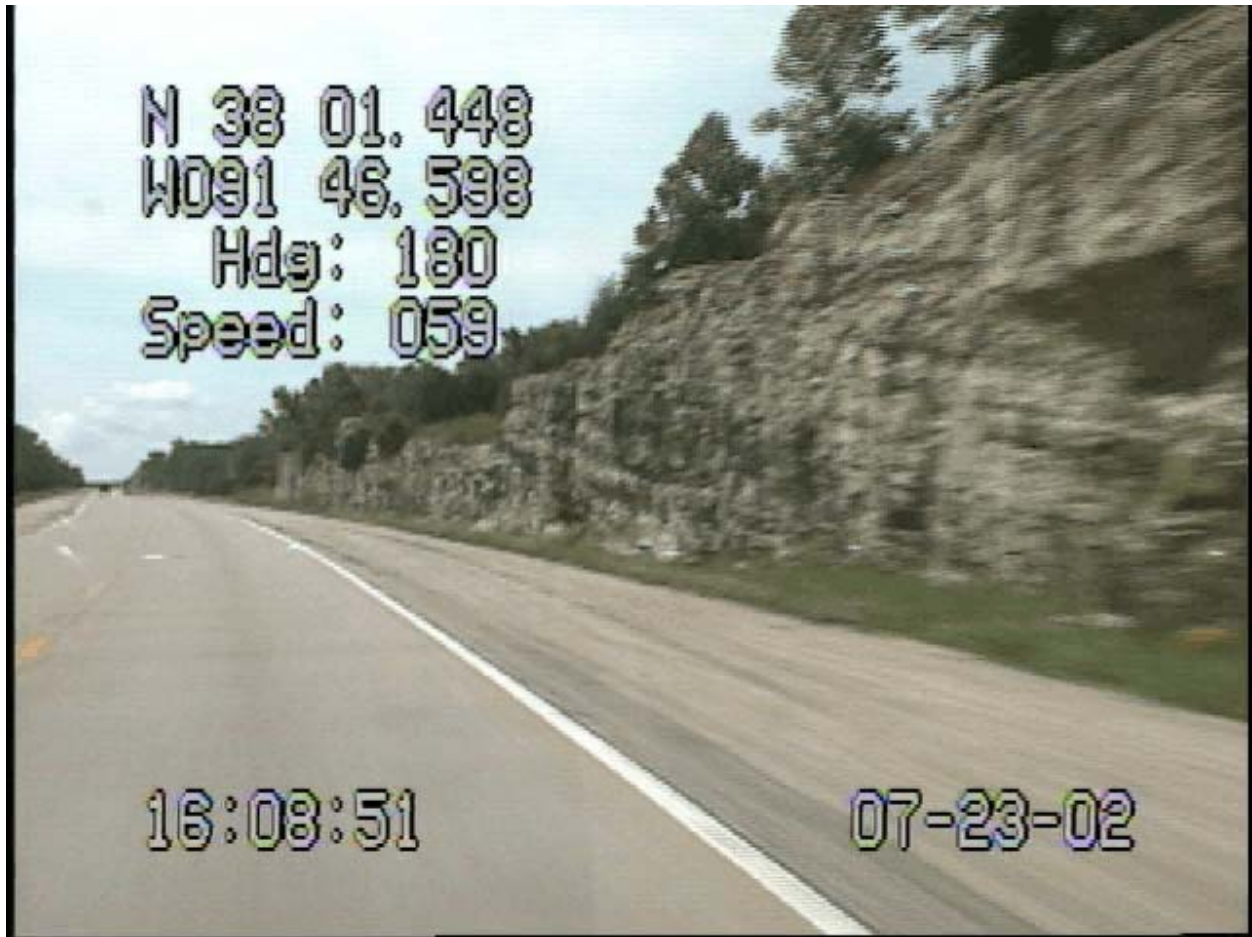
FIGURE 2 Video frame with overlain GPS coordinates, heading, speed, time, and date.

The concept of using video images is simple. Video images can be taken at highway speeds by technicians, digitally recorded, and evaluated back in the office by the engineer or geologist. The engineer or geologist can quickly select the areas where stability may be an issue, and pick locations for site evaluations, preparing hard copies of images to take to the field to facilitate the identification of problem areas. Figure 1 shows the hardware setup, which consists of a digital camera mounted on the dash of a vehicle. Figure 2 shows an example of a video image, with GPS coordinated generated by a simple hand-held GPS device.

FIGURE 2 Video frame with overlain GPS coordinates, heading, speed, time, and date.

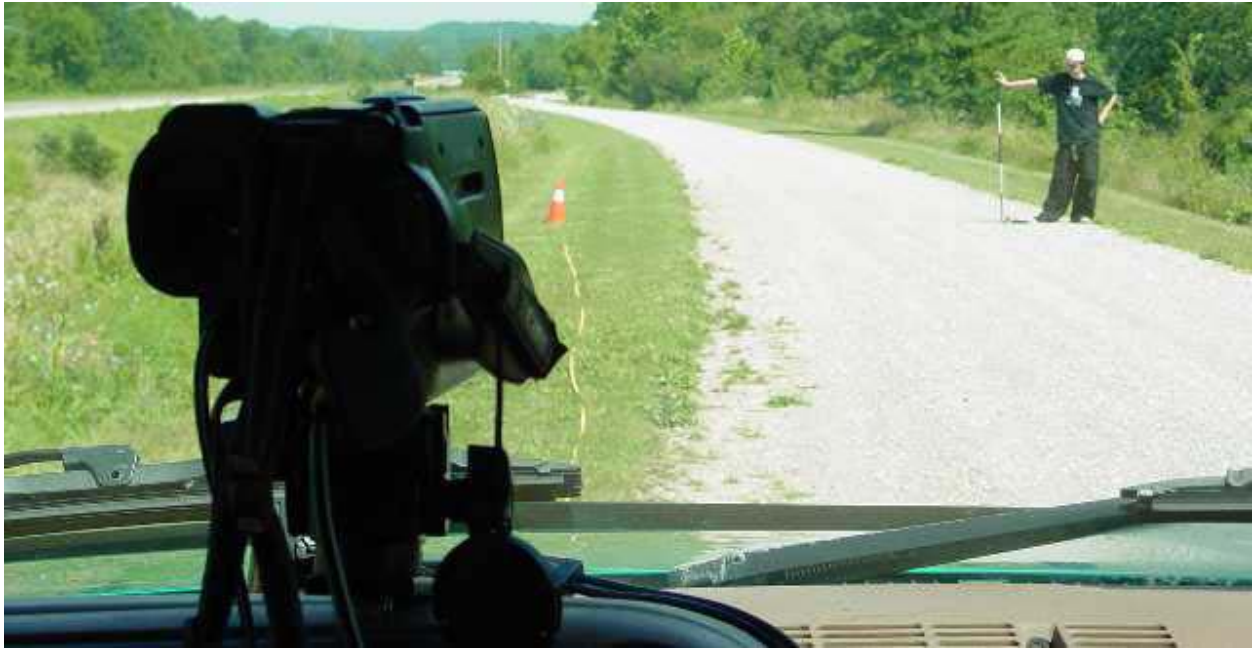
FIGURE 4 Aiming the camera at an angle of 10° to the left of the direction of travel vector.

Horizontal alignment should be set to about 10° to the left of the direction of travel. This is best accomplished by stretching a tape measure 100' in the direction of travel, stretching a second tape measure 17.6' at 90° and to the left, placing a vertical object, and centering the camera on that object (Figure 4).

FIGURE 4 Aiming the camera at an angle of 10° to the left of the direction of travel vector.

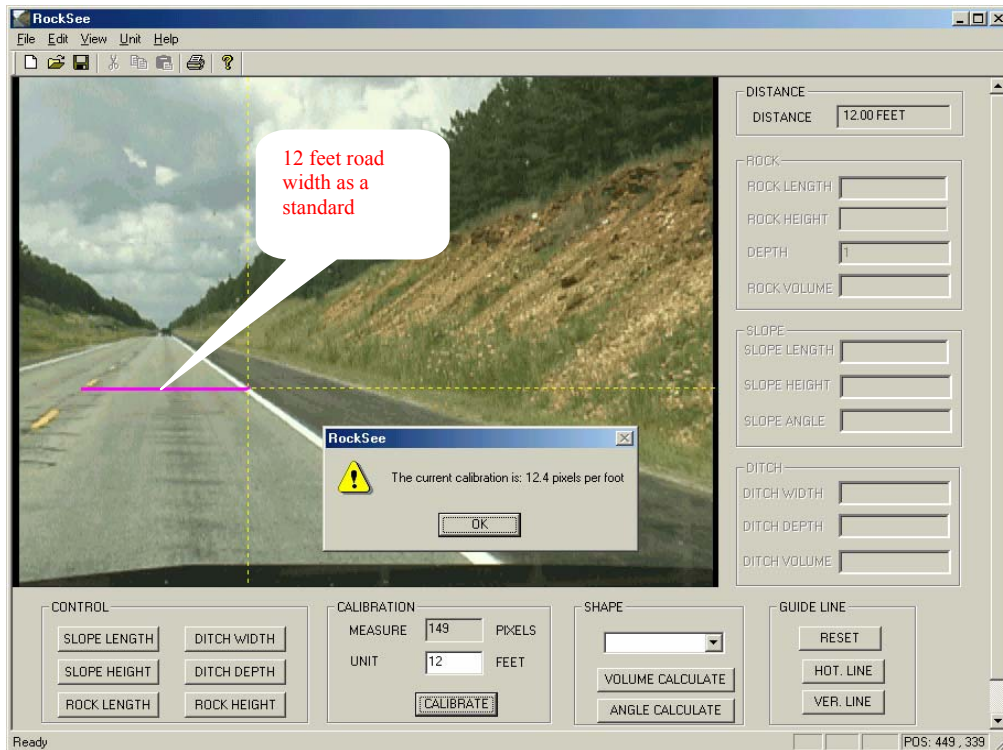
FIGURE 5 Calibration of scale using a vertical scaling device (top). (This calibration is valid only in the vertical plane defined by the horizon dotted yellow line.) This calibration is valid in any image, in the plane anchored by the yellow vertical line and the white edge line of the road. Bottom: Calibration of scale using road width.

Scale calibration is required. This can be done by taking an image such as in Figure 5, with a scaling object in the image. The portion of the image that the scaling is valid for is defined by a vertical plane, perpendicular to the camera vector, and that passes through the point defined by the painted white road edge line and the vertical dotted line that is arbitrarily placed 1/3 of the way into the image from the left hand side. This scale remains constant for that position in all images, but makes the assumption that the roadway is straight between the vehicle and the plane of measurement.

When an image is loaded, the yellow vertical line 1/3 of the way across the image is automatically drawn in (Figure 5). The user selects the “HOT LINE” option and clicks on the intersection of the vertical yellow line and the painted white road edge line. This puts in place a horizontal dashed line that with the vertical dashed line defines the measurement plane (Figure 5). Figure 6 defines the measuring concept.

FIGURE 5 Calibration of scale using a vertical scaling device. (This calibration is valid only in the vertical plane defined by the horizon dotted yellow line.) This calibration is valid in any image, in the plane anchored by the yellow vertical line and the white edge line of the road.

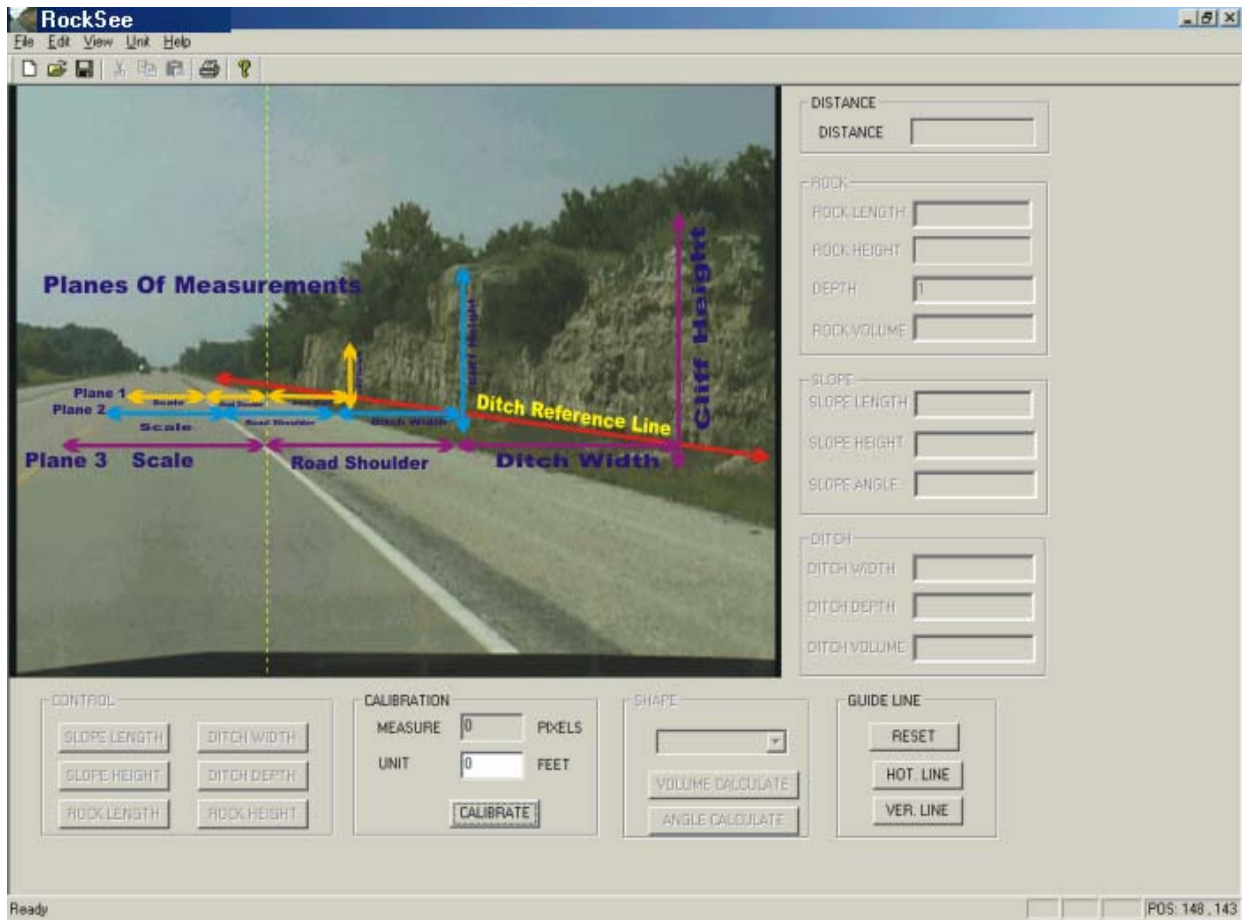
FIGURE 7 Multiple planes of measurement on a single image.

The scale can also be determined at different points on an image (Figure 7). It is important to note, only the scale anchored on the painted white road edge line can be carried forward to another frame.

FIGURE 7 Multiple planes of measurement on a single image.

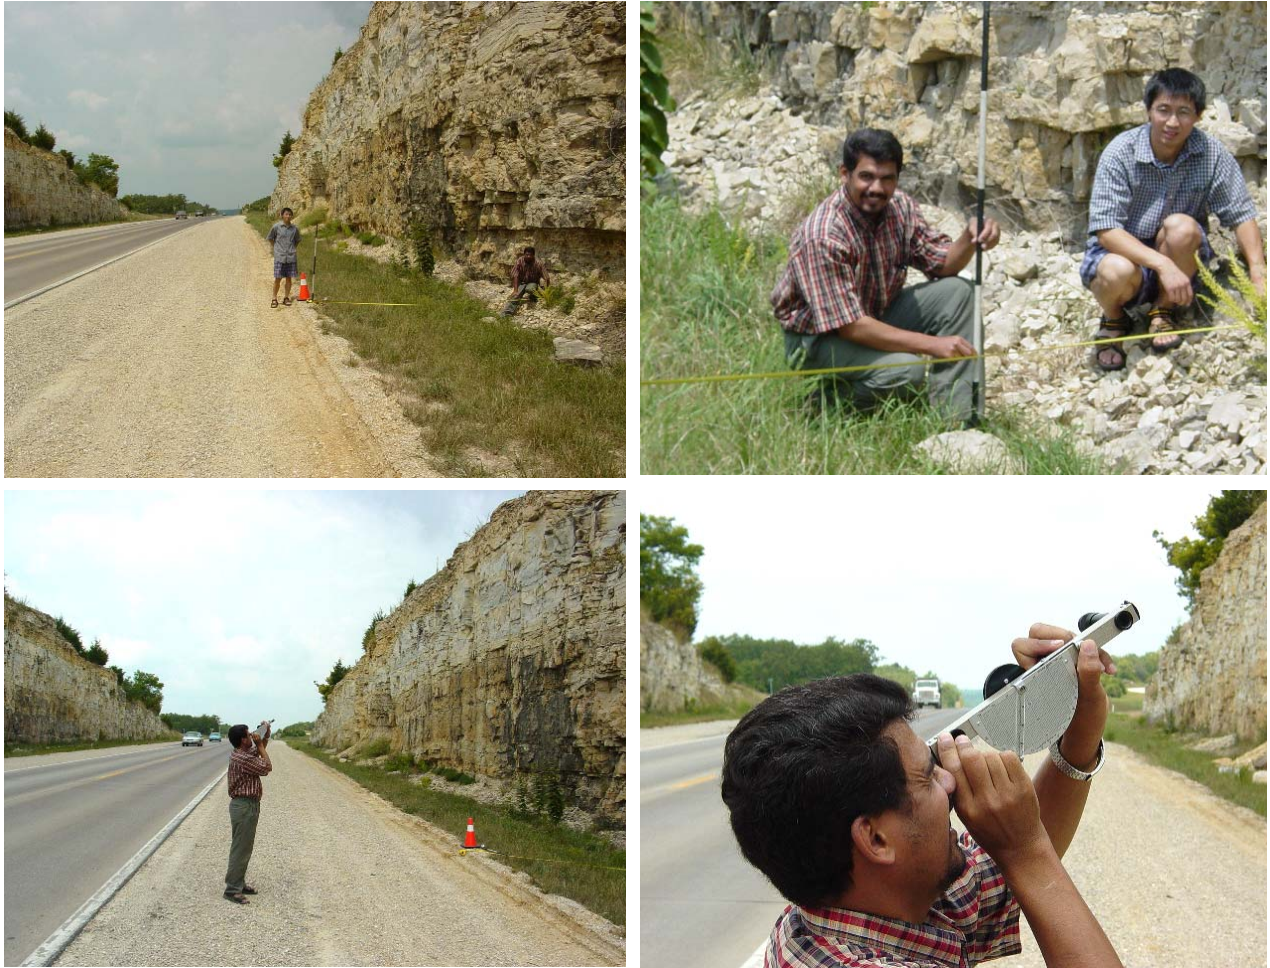
FIGURE 8 Manual measurements of road widths, ditch widths and depths, and slope heights and angles.

To test the measuring system, 17 locations were selected along state highways, and manual measurements of measurements of road widths, ditch widths and depths, and slope heights and angles were conducted using tape measures, measuring rods, and a range-finding clinometer (Figure 8).

FIGURE 8 Manual measurements of road widths, ditch widths and depths, and slope heights and angles.

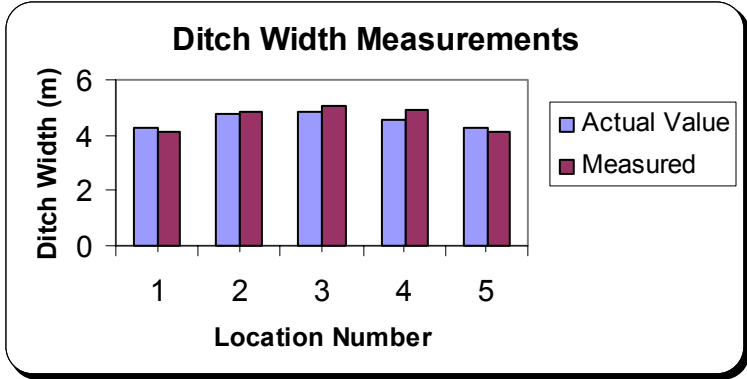
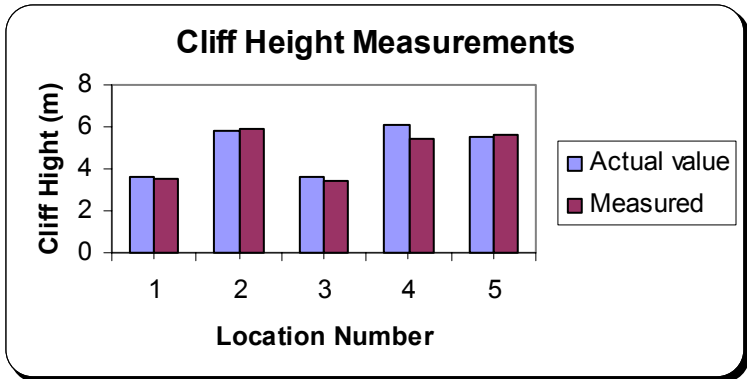
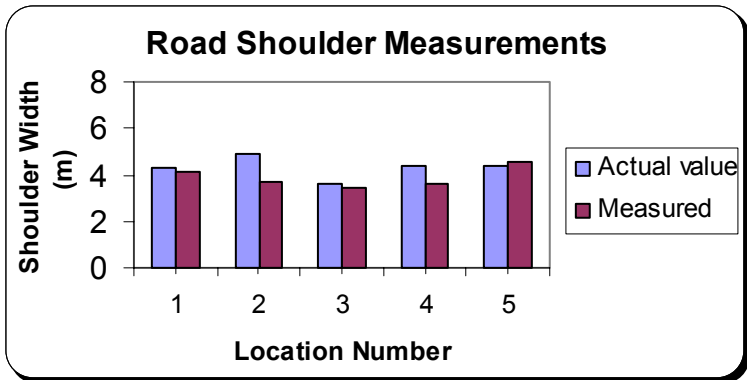
FIGURE 10 Error results for test #1

FIGURE 10 Error results for test #1

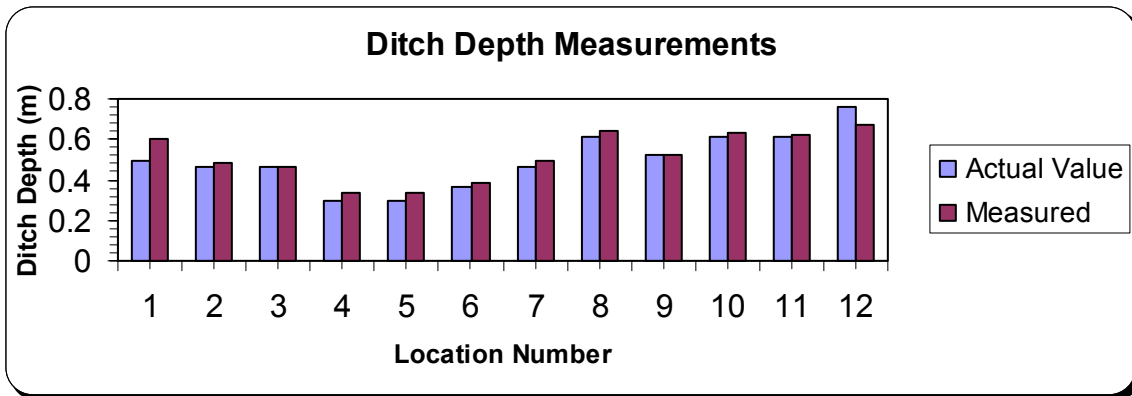
FIGURE 12 Error results for test #2.

FIGURE 12 Error results for test #2
